Technical Report on the Status of the Walkerton Water Supply System

Technical Report

November 2000

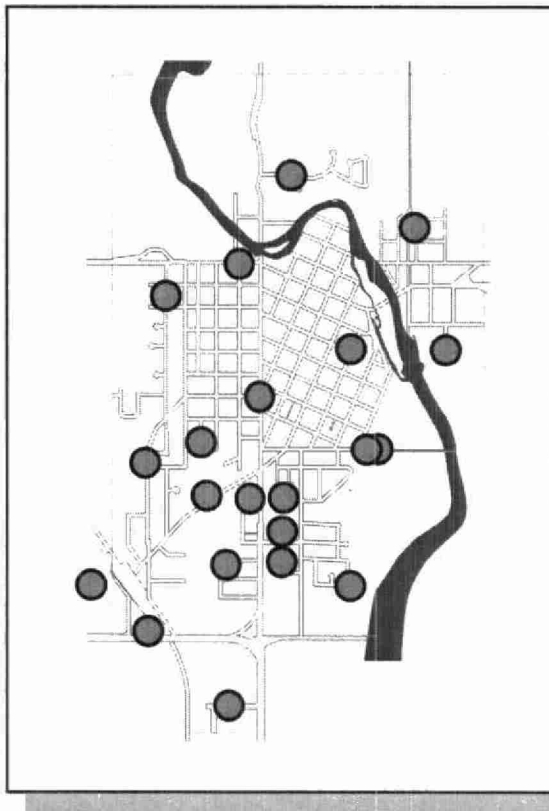
Figure 3: Distribution System Sampling Sites

In order to monitor the ongoing microbiological quality of the Walkerton water supply and to comply with a Ministry order, OCWA initiated a comprehensive distribution system sampling program on May 29, 2000. Twenty-one strategically located sampling stations were selected throughout the community for daily sampling (see Figure 3). In addition, untreated and treated water from each well in production was sampled daily.

The sample locations used by OCWA were selected to meet a variety of criteria. The locations were dispersed throughout the distribution system to provide for complete coverage. Two locations were selected where the water supply from the wells enters the distribution system. Samples were also taken in the vicinity of both standpipes. The other sample locations were selected based on historical information, including the locations of known dead-ends.

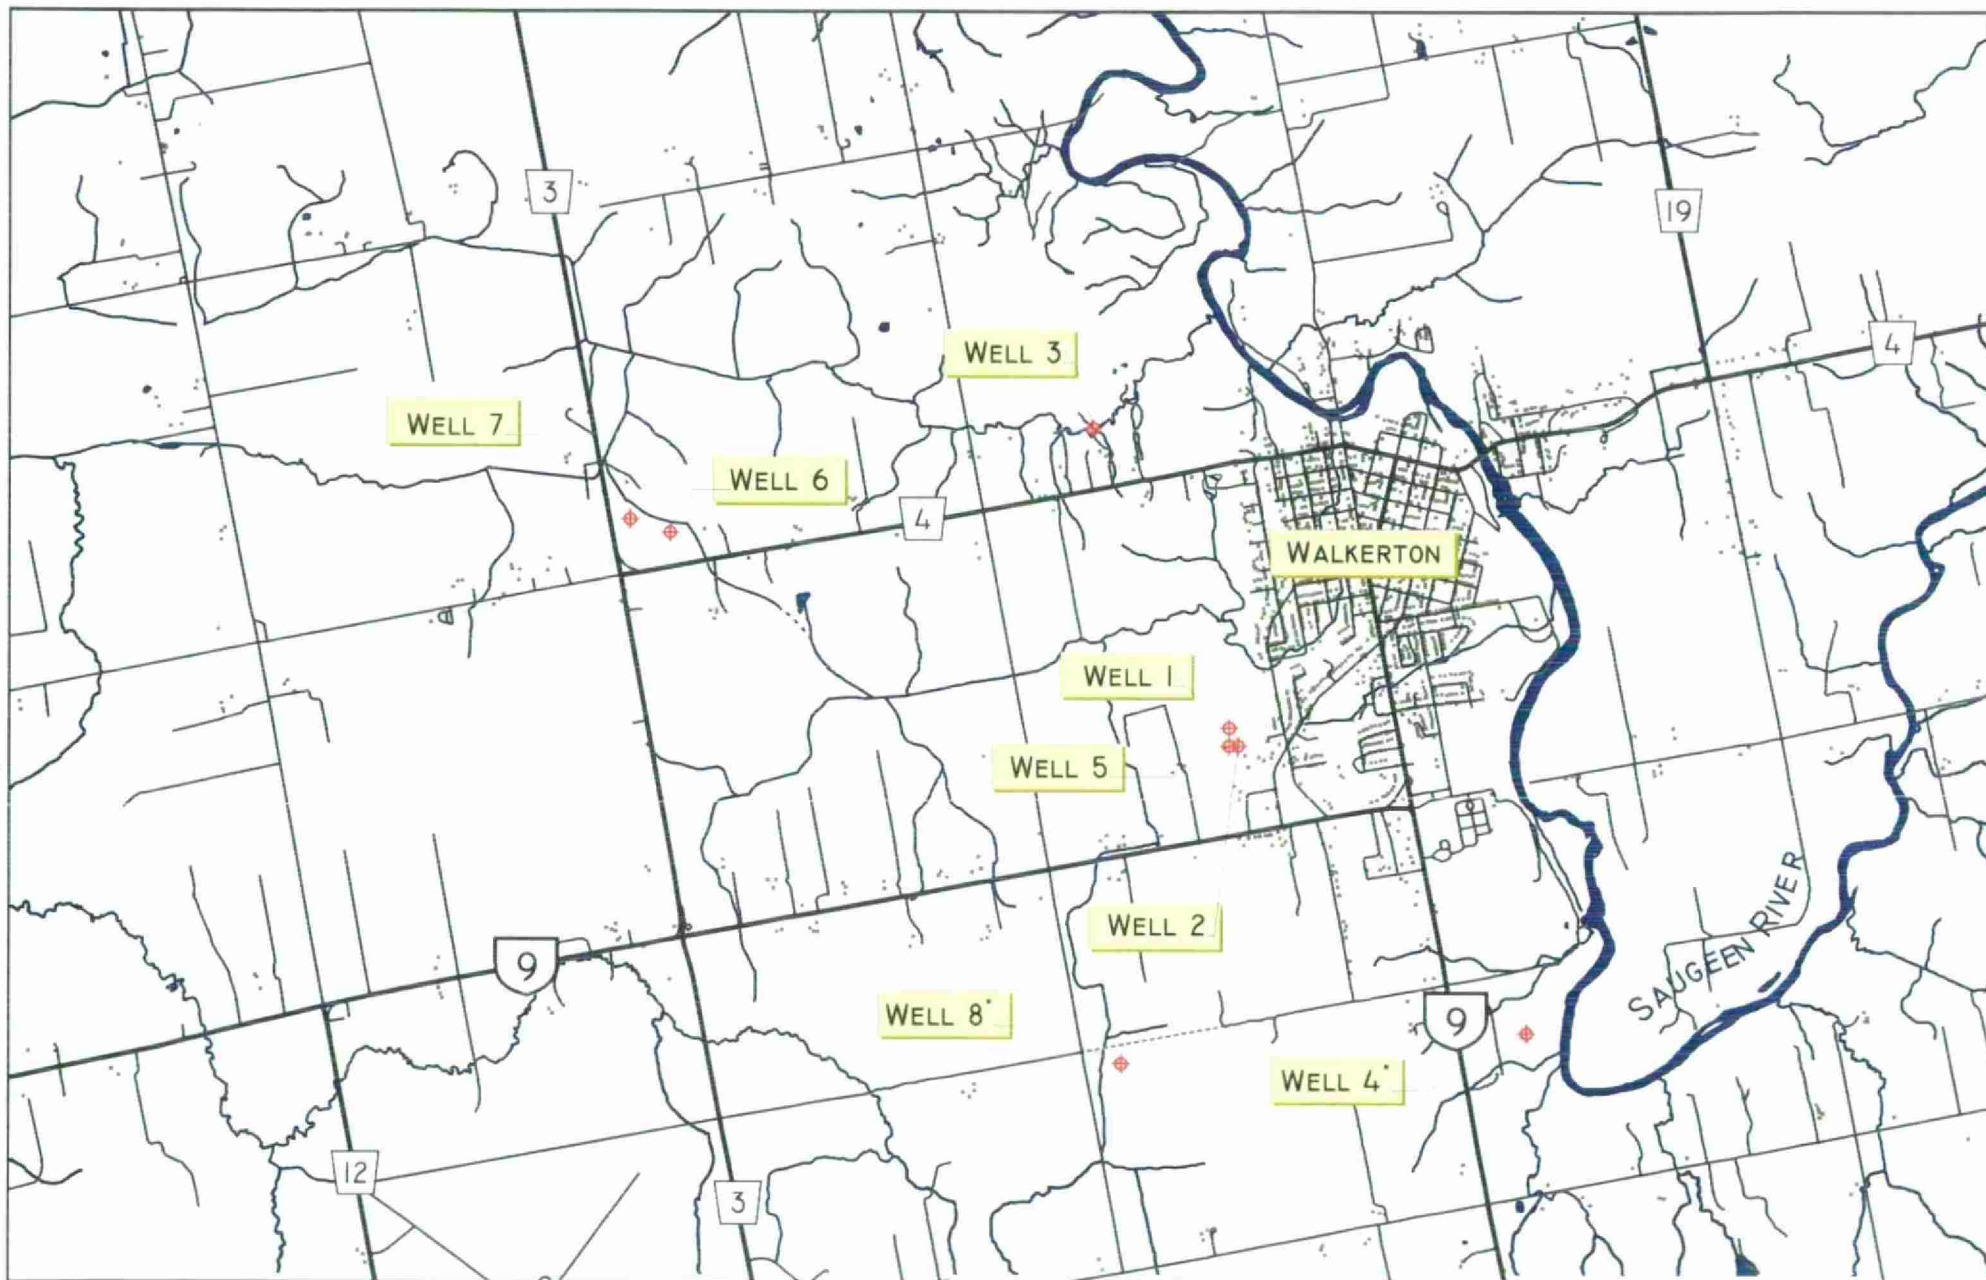
FIGURE 4

A map showing the locations of Walkerton's wells is included as Figure 4.

Well 3 is connected to the distribution system between Wells 6 and 7 and the main part of Walkerton (see Figure 4). Therefore, water from the well could have entered the distribution system without having been treated by the filtration treatment system. The Ministry, therefore, requested that Well 3 be disconnected from the distribution system. The pump has been removed from the well, creating a physical separation between the well and the distribution system.
